WEA Napier Conference

Havelock North Water Crisis

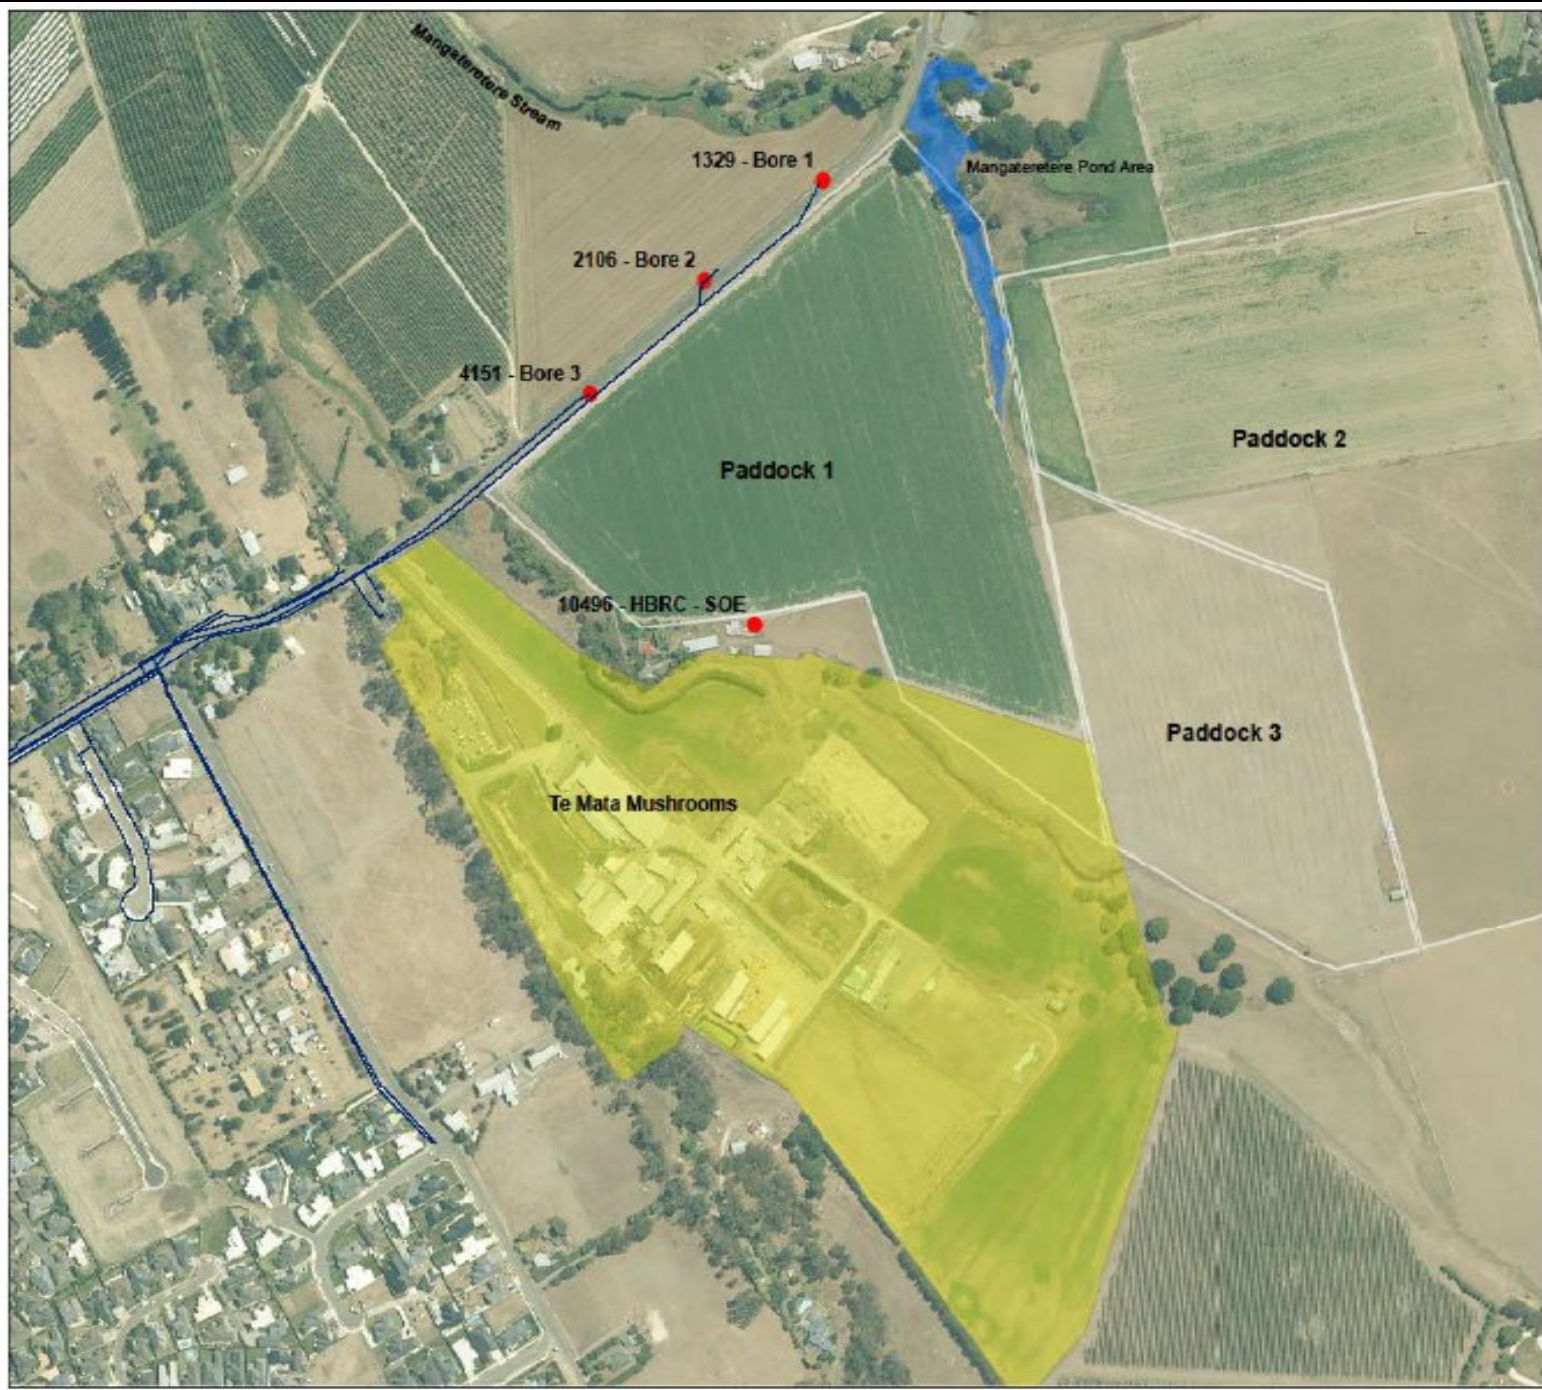
**Havelock North
Borefield**

- Likely caused by heavy rain, inundating sheep paddocks.
- Contaminated water flowed into a pond, entering the aquifer.
- Te Mata aquifer is not confined.
- Te Mata aquifer is believed to have been compromised by nearby earthworks.
