NHAP

‘Winery Resources

Future Challenges’

Critical LV Switchgear

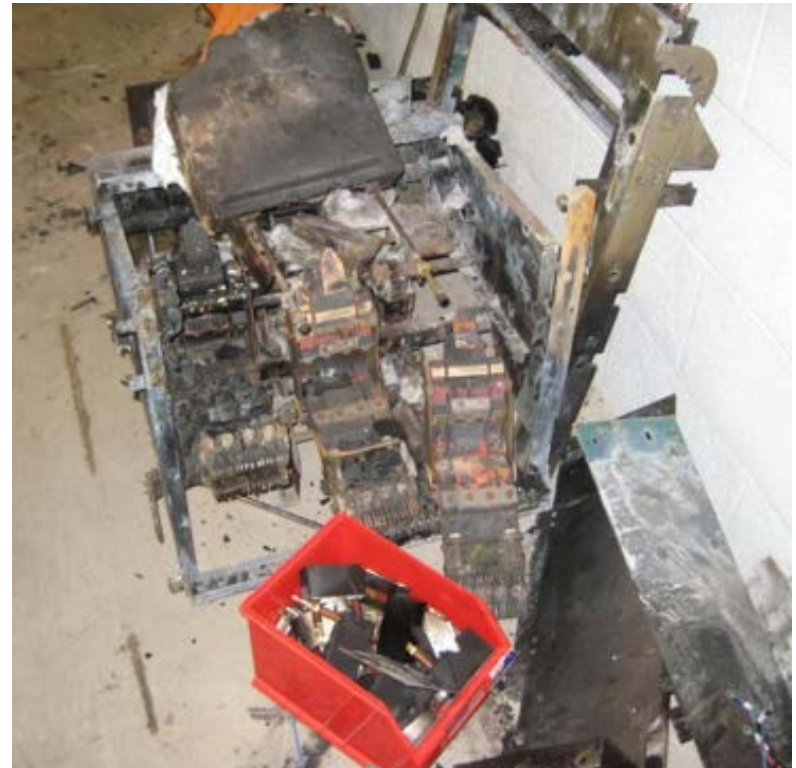
Maintain: Aging Electrical Infrastructure

- 3% typical failure rate first 5 years
- Wearing of mechanical gears
- Burning out of coils
- Auxiliary Contacts become unreliable
- Faulty tripping mechanism
- Overheating of main contacts
- Trip unit failure (15-20 years)

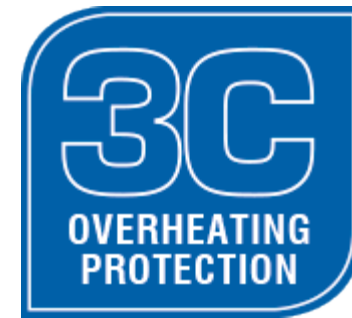
Monitor: Predictive Maintenance

- Heat is a key indicator:
- IR scans
- Switchboard temperature sensors
- ACB integrated overheating sensors

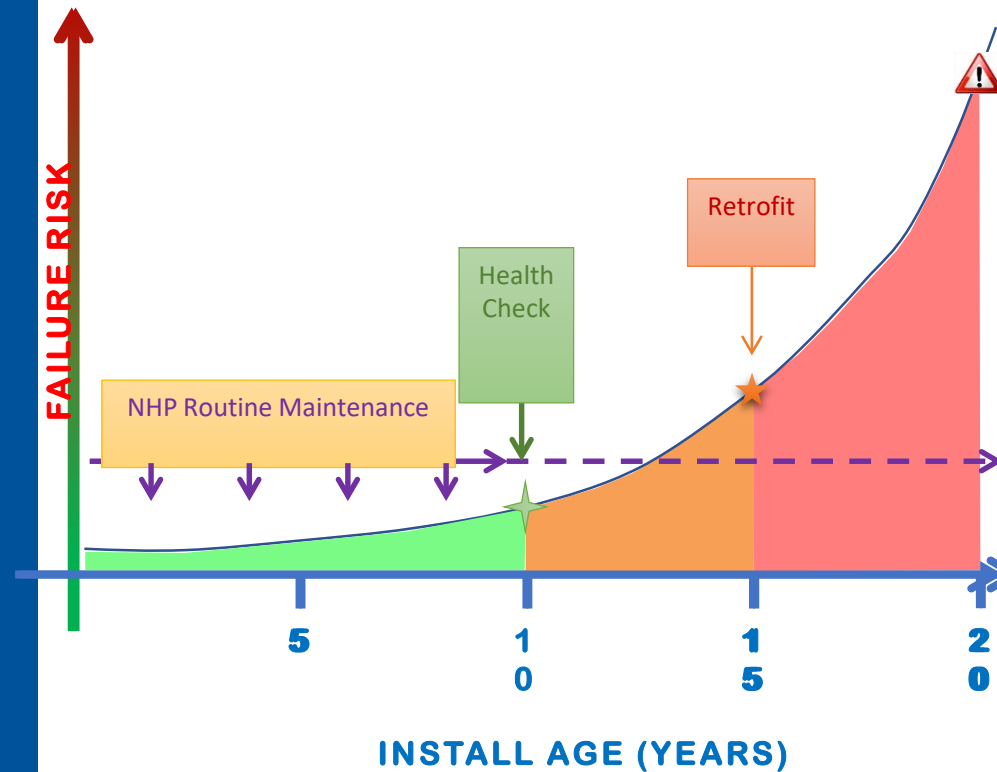
Modernisation: ACB Lifecycle

- Many of the ACBs in service are no longer manufactured. These have been superseded over time by newer models.
- Depending on the age and the place of manufacture, parts and servicing may not be available.
- Servicing (when possible) is also expensive and mostly requires the ACB to be worked on at the service company's factory. This does not take into account the plant down-time.
- Although ACBs are generally reliable devices, they are subject to deterioration over time as is all mechanical/electrical equipment.

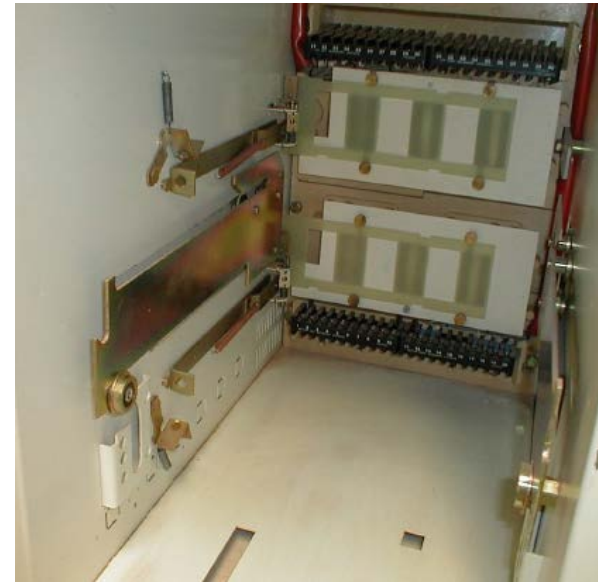
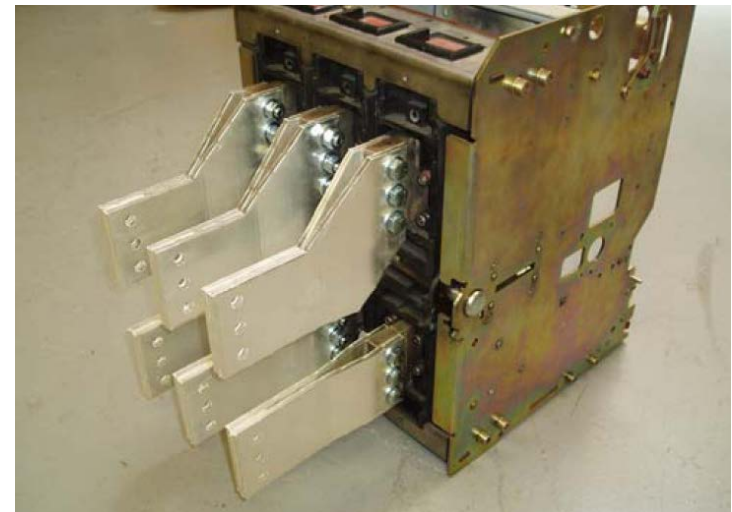
Modernisation: Retrofit Solutions

- Retrofit : this is the remaking of connections to suit the new ACB. Typically the existing carriage remains in an altered form.
- Installation : duplicates the connection and fixing points of the original ACB. Typically the existing carriage is fully removed. Switchboard isolation is required.

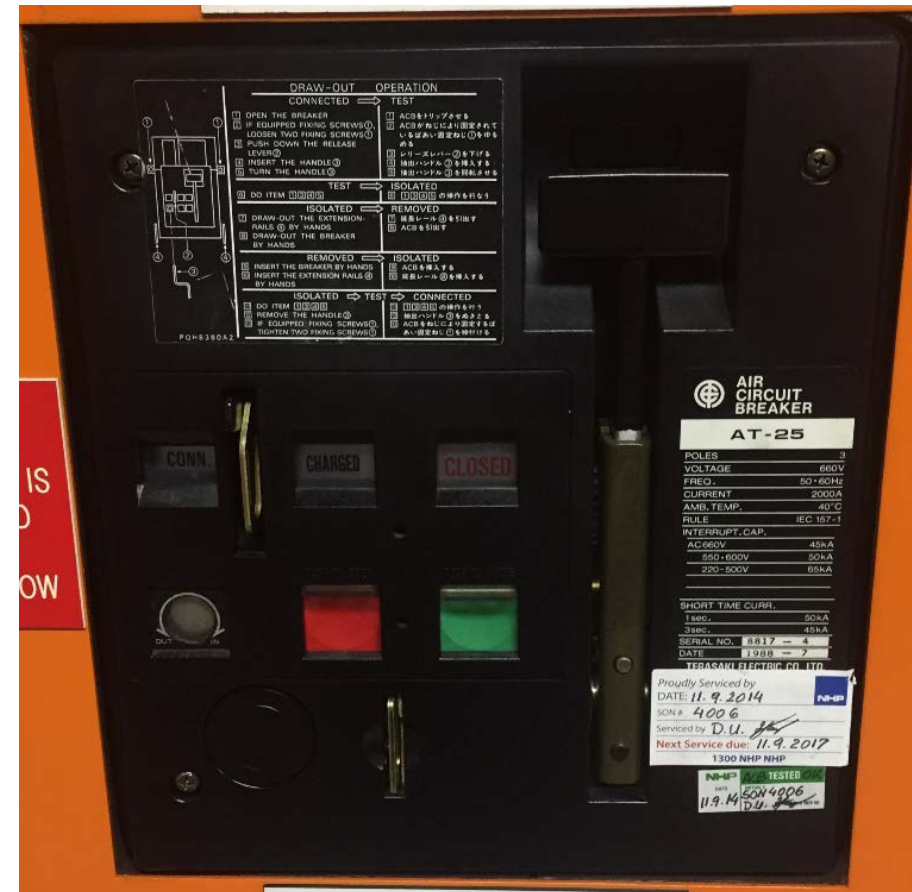
Modernisation: Retrofit Failing Switchgear

- More cost effective than full replacement
- Shorter shut down time
- Introduce the latest protection technology
- Extend the life of the switchboard
- More environmentally friendly
